Preliminary Report  
on the Absolute Dating of the  
Khufu Pyramid Using the  
Relative Erosion Method (REM)

Author: Alberto Donini<sup>1</sup>

Affiliation: University of Bologna, Italy

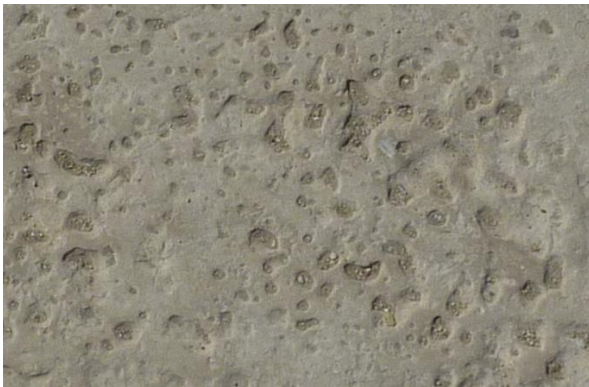
Pitting erosion (or pitting) in rock is a form of point-like degradation that produces small cavities or blind holes on the surface. It is caused primarily by chemical agents (such as salts or acids) and physical agents (including freeze–thaw cycles and plant root action), and is often promoted by the presence of water and dissolved salts. This process typically manifests as clusters of closely spaced holes that can progressively deepen, leading to significant deterioration of the stone material. Pitting erosion represents a type of localized corrosion that affects specific points on the surface, resulting in material loss, and is commonly observed in exposed marble, sandstone, and limestone, particularly in coastal or humid environments.

Fig. 2 Pitting erosion on limestone rock.

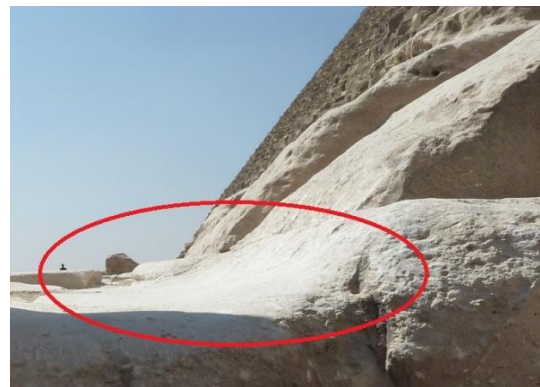
This type of erosion manifests as a smooth or polished surface, or, in some cases, as a layered appearance of the eroded or worn rock.

Fig. 3 Uniform erosion on limestone rock.

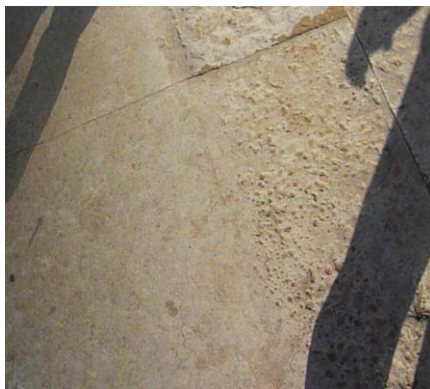
Fig. 4 Paving at the base of the Pyramid of Khufu at point 1. Fig. 5 Base of Akhet Khufu with the few remaining limestone blocks of the cladding.

Fig. 4 illustrates one of the analysed points, corresponding to a portion of the northern pavement at the base of the Pyramid of Khufu. The left-hand side of the pavement was originally covered by limestone casing blocks, which were removed approximately 675 years

ago, whereas the right-hand side has remained continuously exposed to atmospheric agents since the time of construction and consequently exhibits significantly greater surface erosion. The ratio between the erosion observed on these two adjacent surfaces provides the basis for estimating the construction date of the pyramid.

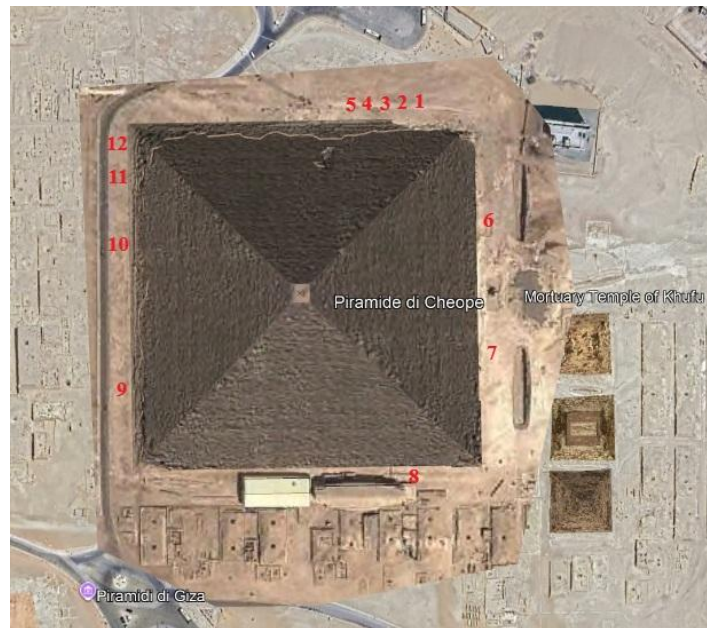
Fig. 6 The G1 pyramid of Akhet Khufu, with the points where I measured relative erosion marked in red (picture from Googleearth)

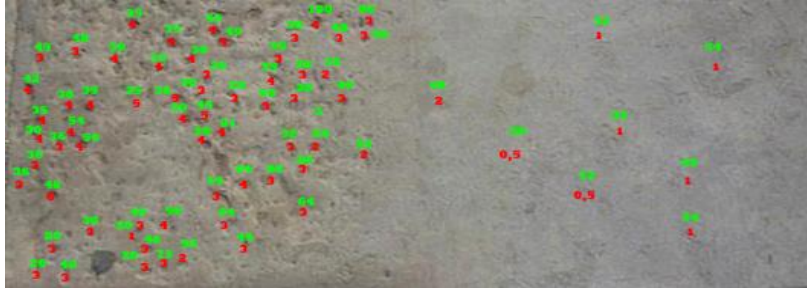
Fig. 8 Calculation of erosion (volume of holes) in point 2: on the right, the part of the limestone pavement exposed to erosive agents for approximately 675 years; on the left, the part exposed since the time of construction.

In this image, the area (highlighted in green) and the depth (highlighted in red) of each recess were calculated and expressed in square millimetres and millimetres, respectively. The total volume of eroded rock at analysis point 2 was then determined. The left-hand side corresponds to the surface that has been exposed to erosive agents since the time of construction, whereas the right-hand side represents the surface that has been exposed to erosive agents for approximately 675 years.

Total volume of eroded recesses in exposed part: 9,124 mm<sup>3</sup>

Total volume of eroded recesses in exposed part 675 years B.P.: 343 mm<sup>3</sup>

Date of construction:  $9,124 \times 675 / 343 = 17,955$  years B.P.

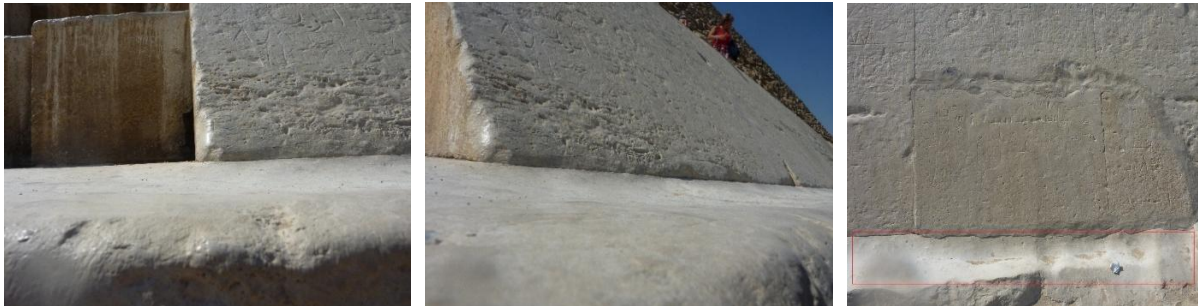
At point 3, I measured the average erosion of the pyramid paving immediately outside the area formerly covered by the removed casing blocks, and compared it with the average erosion of the paving that lay beneath the removed cladding.

Figs. 9 and 10 Wear of the paving immediately outside the cladding blocks at point 3, in Fig. 11 highlighted in the red rectangle.

A few metres apart, points 3, 4 and 5 show uniform erosion with a smooth or undulating appearance. For these points, I considered the average decrease in thickness, noting wear or erosion of the part of the pavement immediately outside the paving blocks, varying from approximately 15 mm to approximately 45 mm.

Average erosion over 675 years B.P.: average 1 mm

Average erosion since the beginning: 3 cm = 30 mm

Construction date:  $675 \times 30 / 1 = 20,250$  years B.P.

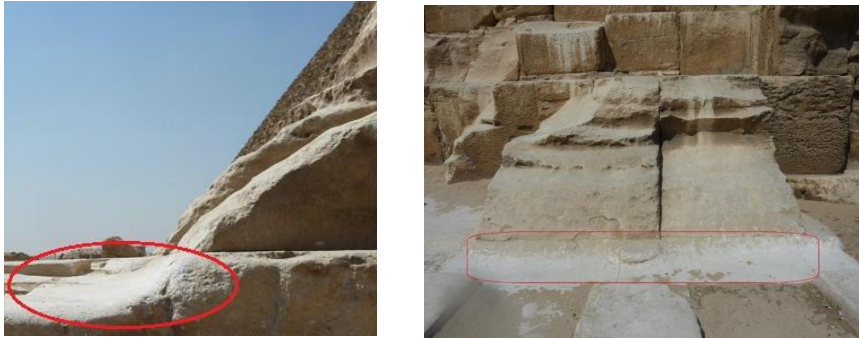
Fig. 12 Wear on the paving immediately outside the paving blocks at point 6, highlighted in the red oval, and in Fig. 13 in the red rectangle.

Average erosion from 675 years B.P.: 1 – 4 mm, average 2.5 mm

Average erosion since the beginning: 11 cm = 110 mm

Construction date:  $675 \times 110 / 2.5 = 29,700$  years B.P.

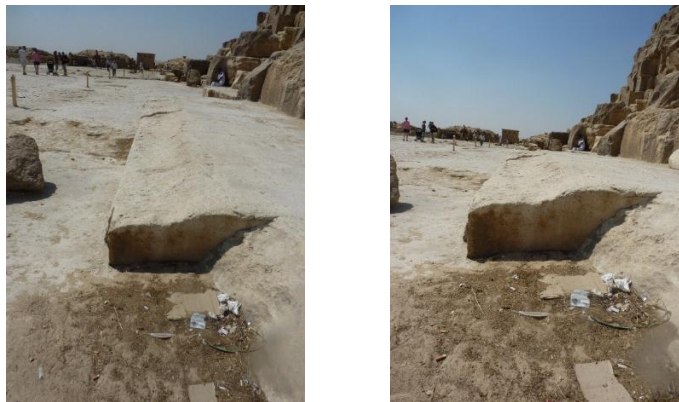
Figs. 14 and 15 Wear or erosion of the paving immediately outside the cladding blocks at point 7.

Average erosion from 675 years B.P.: 1 – 4 mm, average 2.5 mm

Average erosion since the beginning: 10 cm = 100 mm

Date of construction:  $675 \times 100 / 2.5 = 27,000$  years B.P.

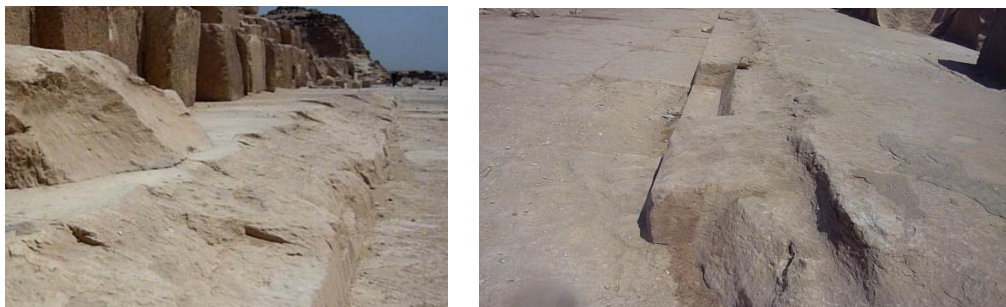
Fig. 16 Wear or erosion of the paving immediately outside the cladding blocks at point 8, and, in Fig. 17, at point 9.

Average erosion from 675 years B.P.: 1 – 4 mm, average 2.5 mm

Average erosion since the beginning: 17 cm = 170 mm

Date of construction:  $675 \times 170 / 2.5 = 45,900$  years B.P.

Average erosion since the beginning: 20 cm = 200 mm

Date of construction:  $675 \times 200 / 2.5 = 54,000$  years B.P.

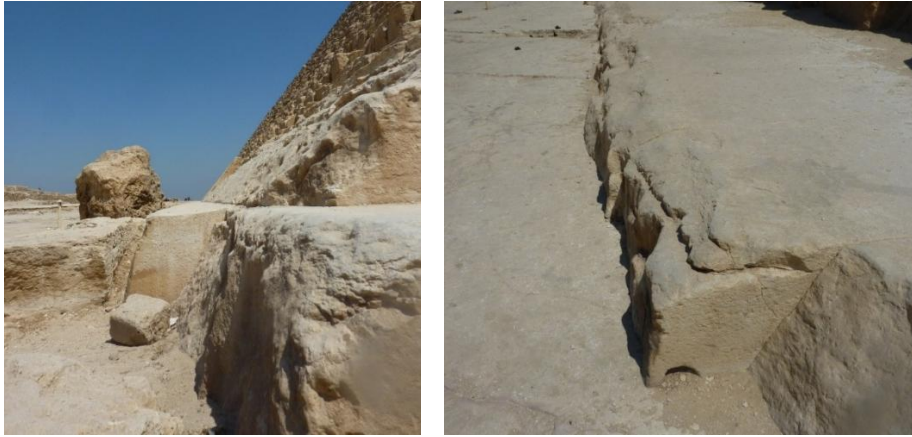
Fig. 18 Wear or erosion of the paving immediately outside the cladding blocks at point 10, and, in Fig. 19, at point 11.

Average erosion from 675 years B.P.: average 1 mm

Average erosion from the beginning: 2 cm = 20 mm

Date of construction:  $675 \times 20 / 1 = 13,500$  years B.P.

Average erosion from 675 years B.P.: 1–5 mm, average 3 mm

Average erosion since the beginning: 10 cm = 100 mm

Date of construction:  $675 \times 100 / 3 = 22,500$  years B.P.

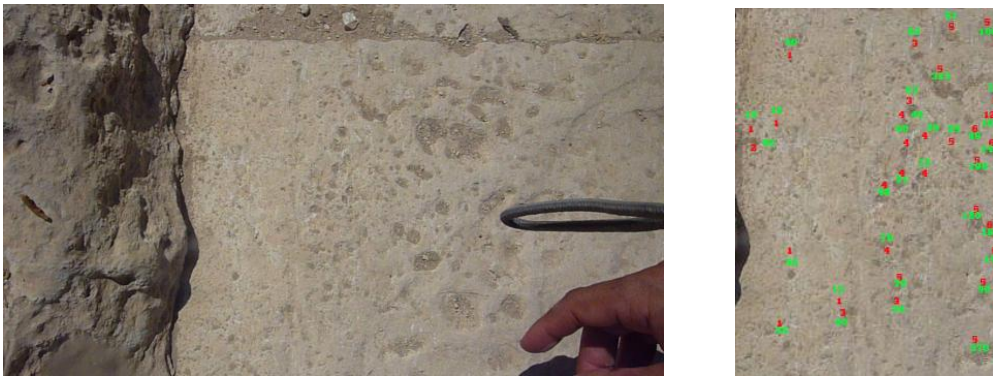
Fig. 20 The difference in erosion at point 12 between the right side (which has been exposed since the pyramid was built) and the left side.

Fig. 21 Calculation of erosion (recess volume) at point 12.

Total volume of eroded recesses in exposed part: 13,072 mm<sup>3</sup>

Total volume of eroded recesses in exposed part 675 years B.P.: 396 mm<sup>3</sup>

Date of construction:  $13,072 \times 675 / 396 = 22,281$  years B.P.
